Earthquake-Induced Ground Fissuring in Foot-Slope Positions of the Port Hills, Christchurch

A thesis

Master of Science in Engineering Geology

University of Canterbury

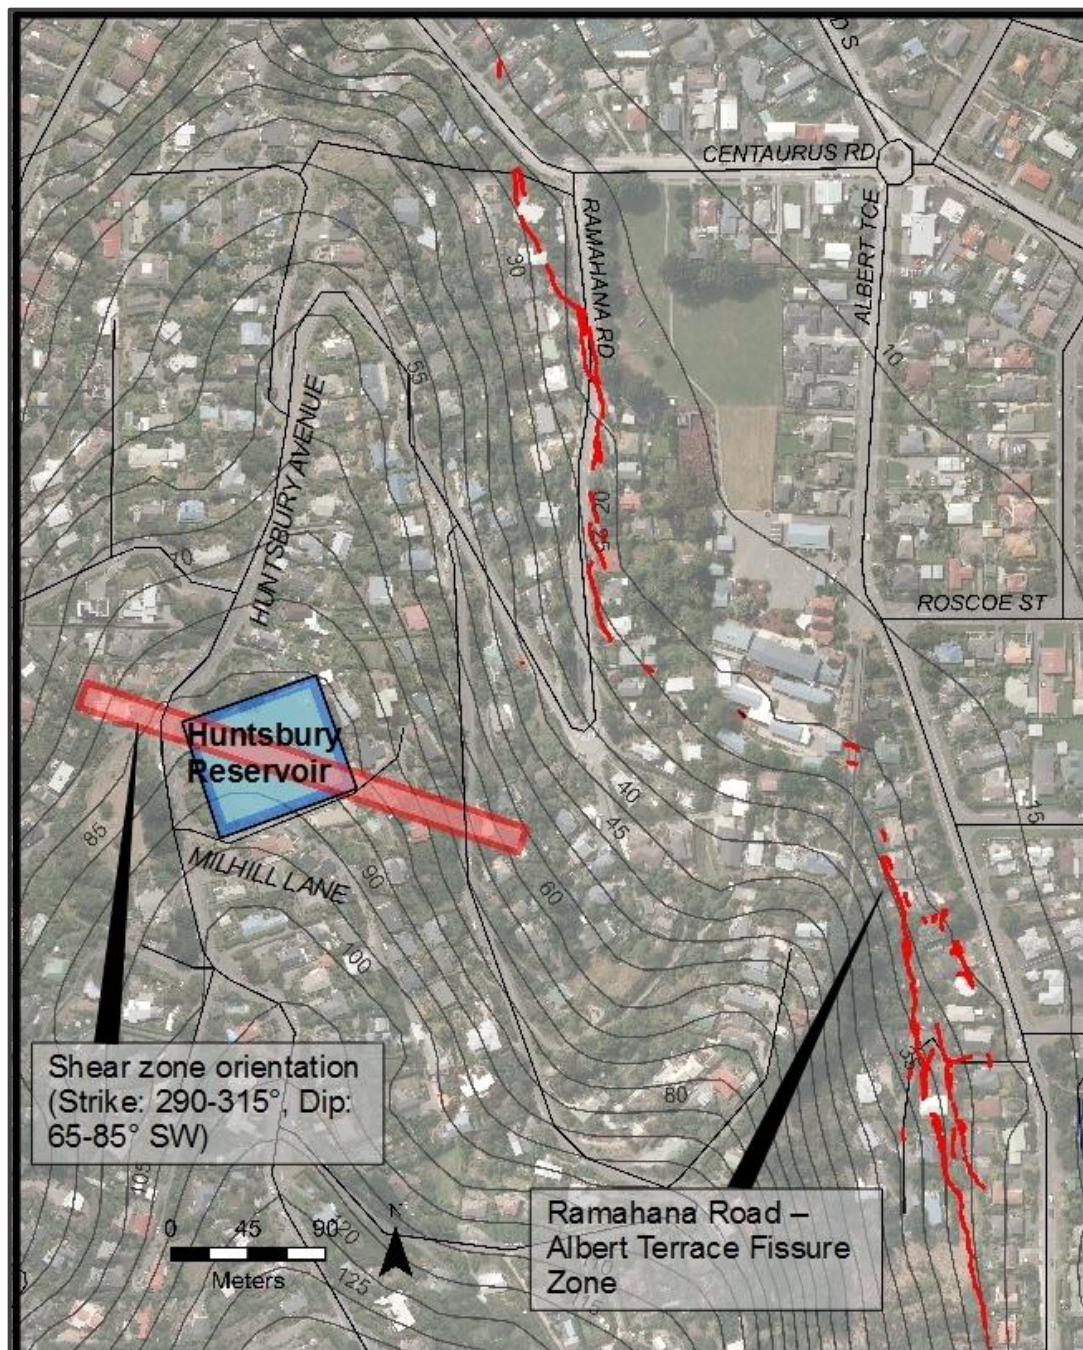
This earthquake caused severe damage to the Huntsbury reservoir, a rectangular reservoir located on the Huntsbury Hill at the intersection of Huntsbury Avenue and Milhill Lane (Figure 3.3). Information on the shearing through the Huntsbury reservoir has been collected by Beca Infrastructure Ltd (2011). The earthquake caused the formation of a series of *en echelon* fractures through the floor of the reservoir in a NW – SE orientation, and the contents (32 000 m³) of the reservoir drained. It is still uncertain as to where the water flowed, as the water was not observed to be concurrently flowing out at any particular location on the hillside. Fractures continued out either side of the reservoir onto nearby roads, with an average strike of 290 - 315°, a dip of 65 - 85° ± 10° SW. The fractures have been interpreted as an historic feature which propagated to the ground surface as a result of the earthquake shaking. This theory

results from the discovery of several well-formed slickenside surfaces, as well as the soft clay “gouge” in the tunnel containing the inlet/outlet pipe to the reservoir.

The orientation of the fractures through the Huntsbury reservoir is of further interest as they appear to line up approximately with the contour-parallel “dog-leg” observed in the Ramahana Road–Albert Terrace fissure trace (Figure 4.11).

Figure 3.3 Location of Huntsbury Reservoir with orientation of fracture zone shown by red rectangle. Relationship to Ramahana Road–Albert Terrace fissure zone shown, with shear zone appearing to align with the fissure “dog-leg”.

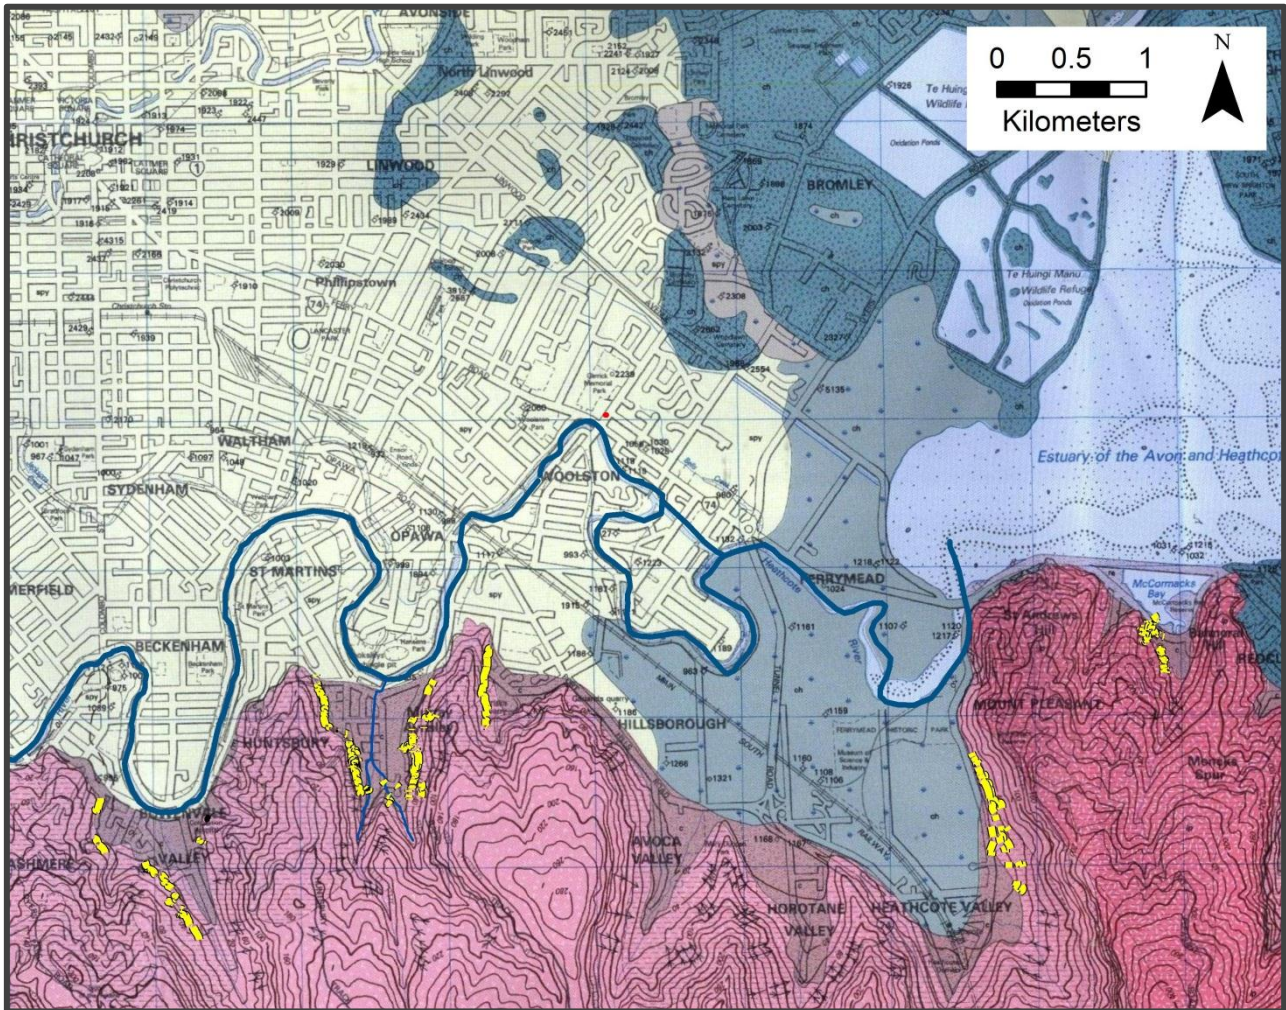
Figure 3.4 Fissure traces overlaid onto geological map of the Christchurch urban area. Fissure traces shown in yellow. Pink rocks are Miocene volcanics, predominantly basalt. Dark pinkish brown shows valley-fill loess colluvium. Pale yellow is alluvial sand and silt overbank deposits. Blue and grey are Christchurch Formation sands, silts and peats. Geologic map is a section from Geology of the Christchurch urban area. Scale 1:25 000. Institute of Geological and Nuclear Sciences geological map by Brown and Weeber (1992).

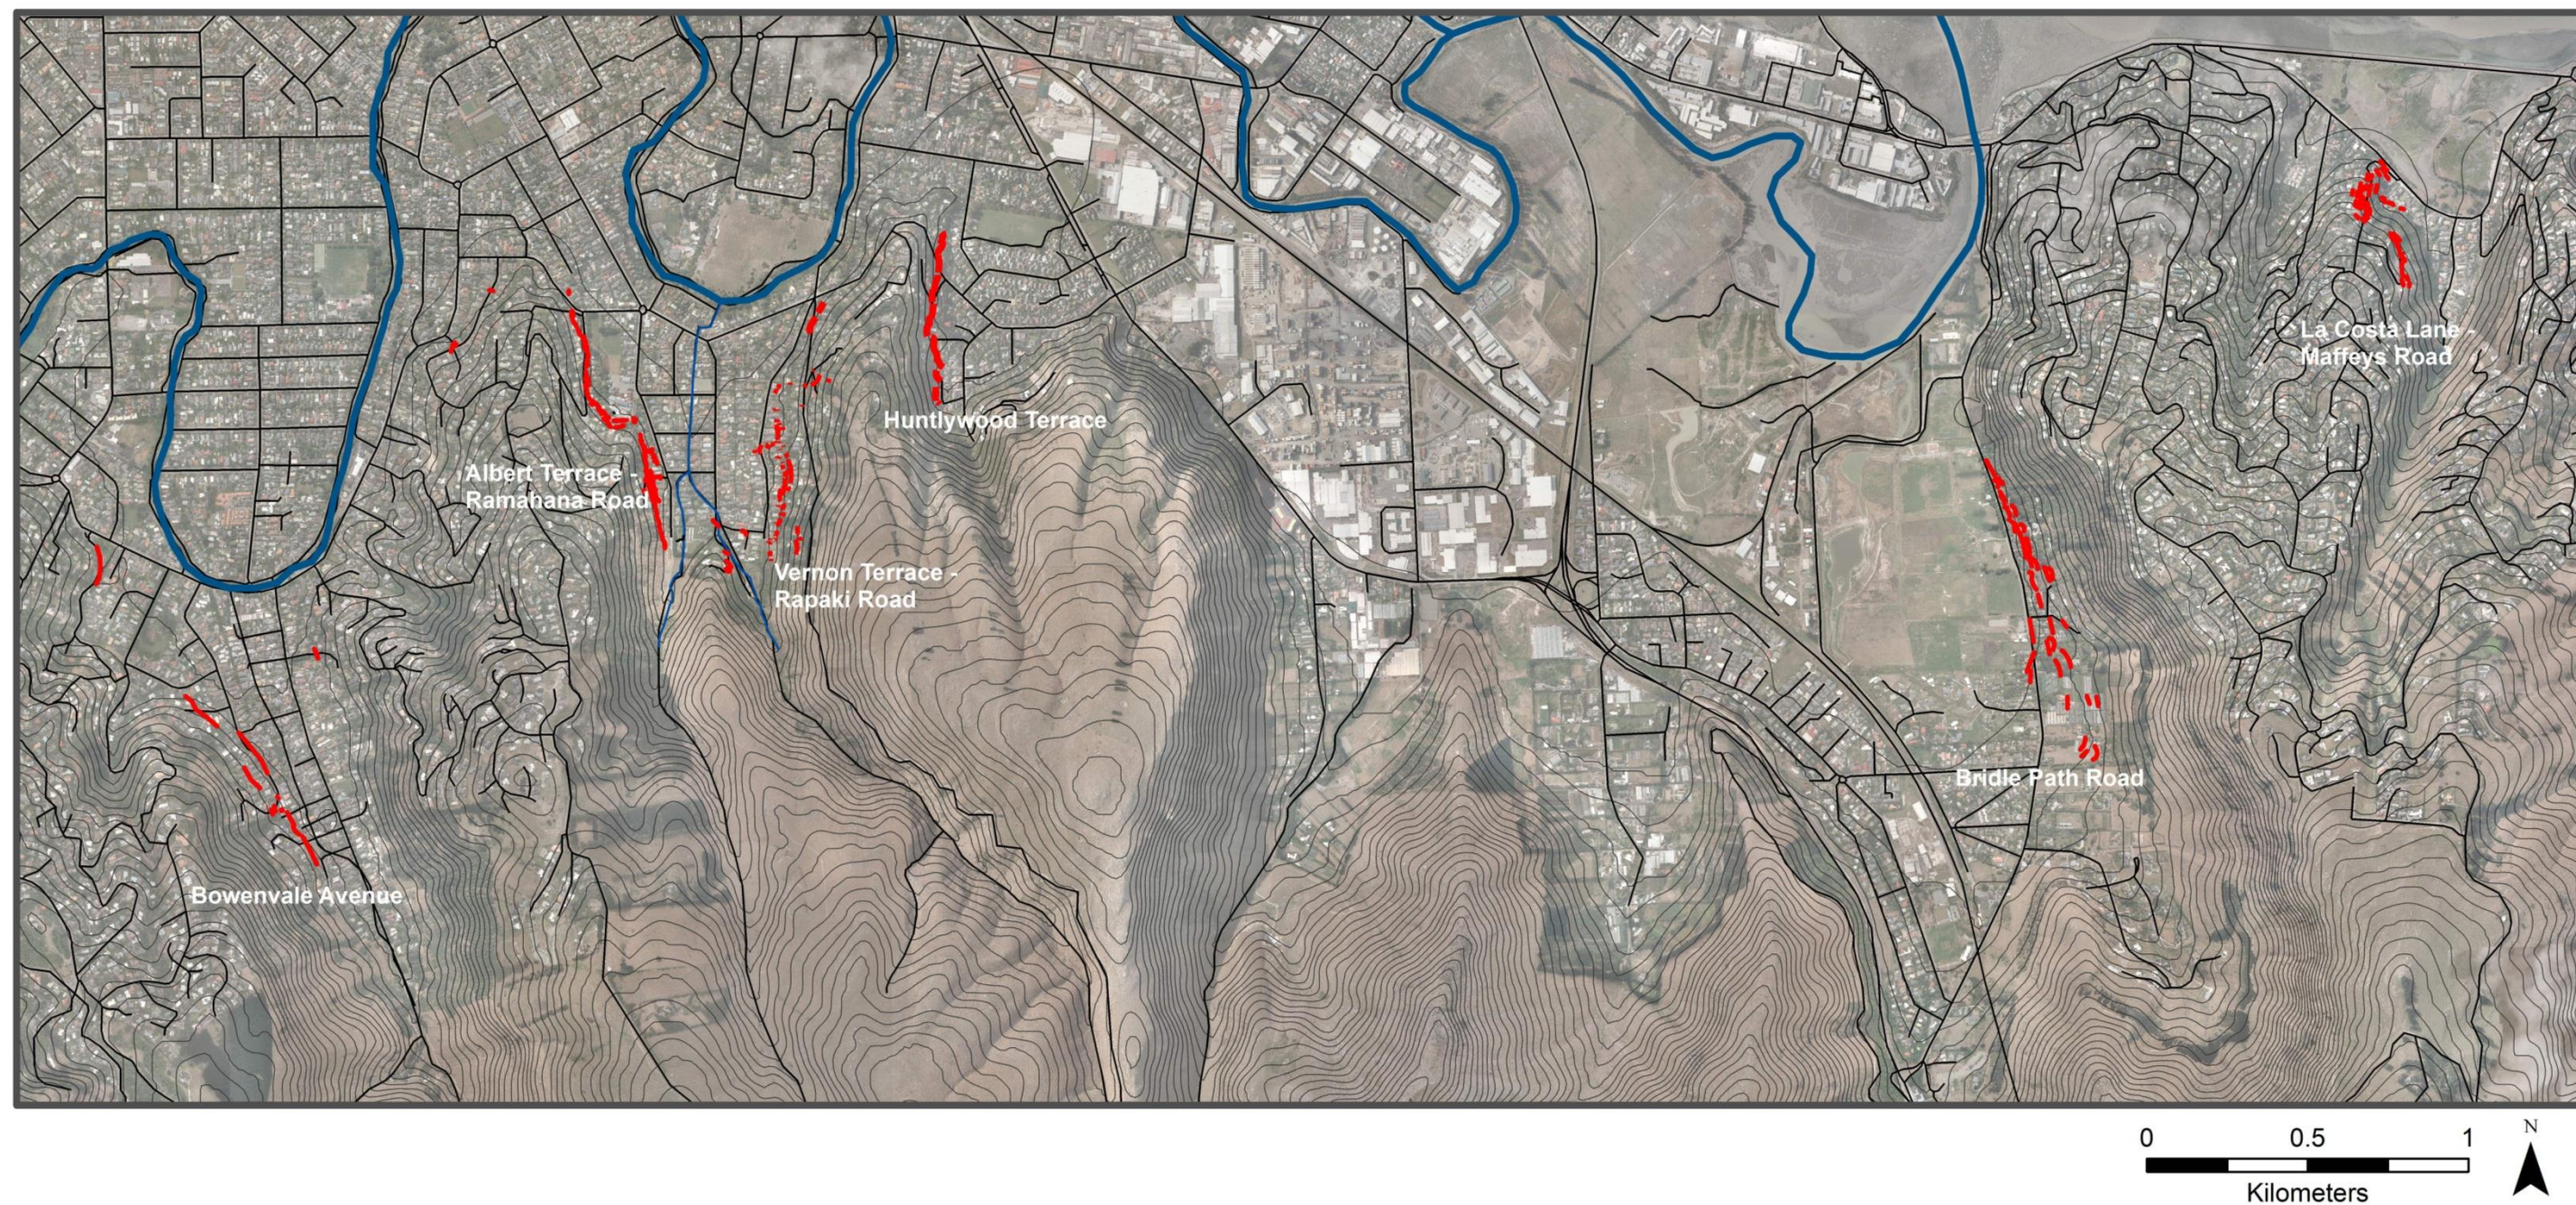
There are five main valley sites of post-earthquake fissuring in the north-facing valleys of the Port Hills, as shown in Figure 3.5, page 52. These sites, from west to east, are: Bowenvale Valley, Hillsborough Valley, Huntlywood Terrace–Lucas Lane, Bridle Path Road, and Maffey's Road–La Costa Lane. The following chapter section will examine the five main fissuring sites and provide a brief overview of each.

The fissure traces are predominantly discontinuous segments, which extend in a zone of varying width along the hillside, in an approximately contour-parallel orientation. When overlaid onto a moderate-resolution geologic map of Christchurch (Brown & Weeber 1992), the fissure traces appear to coincide approximately with the boundary between the hill-mantling loess deposits and the colluvial valley fill (a mixture of re-deposited loess and fragments of volcanic bedrock) as shown in Figure 3.4. In the field it was observed that in most locations (Maffey's Road–La Costa Lane being a notable exception) the fissures appear at least 20 m overland distance below the beginning of outcropping bedrock.

Figure 3.5 Overview map of all fissure traces (red). Mapped by author. Bridle Path Road and Maffey's Road-La Costa Lane traces after maps produced by SKM and URS, Christchurch. Huntlywood Terrace-Lucas Lane trace after pers. comm. R. Hunter.

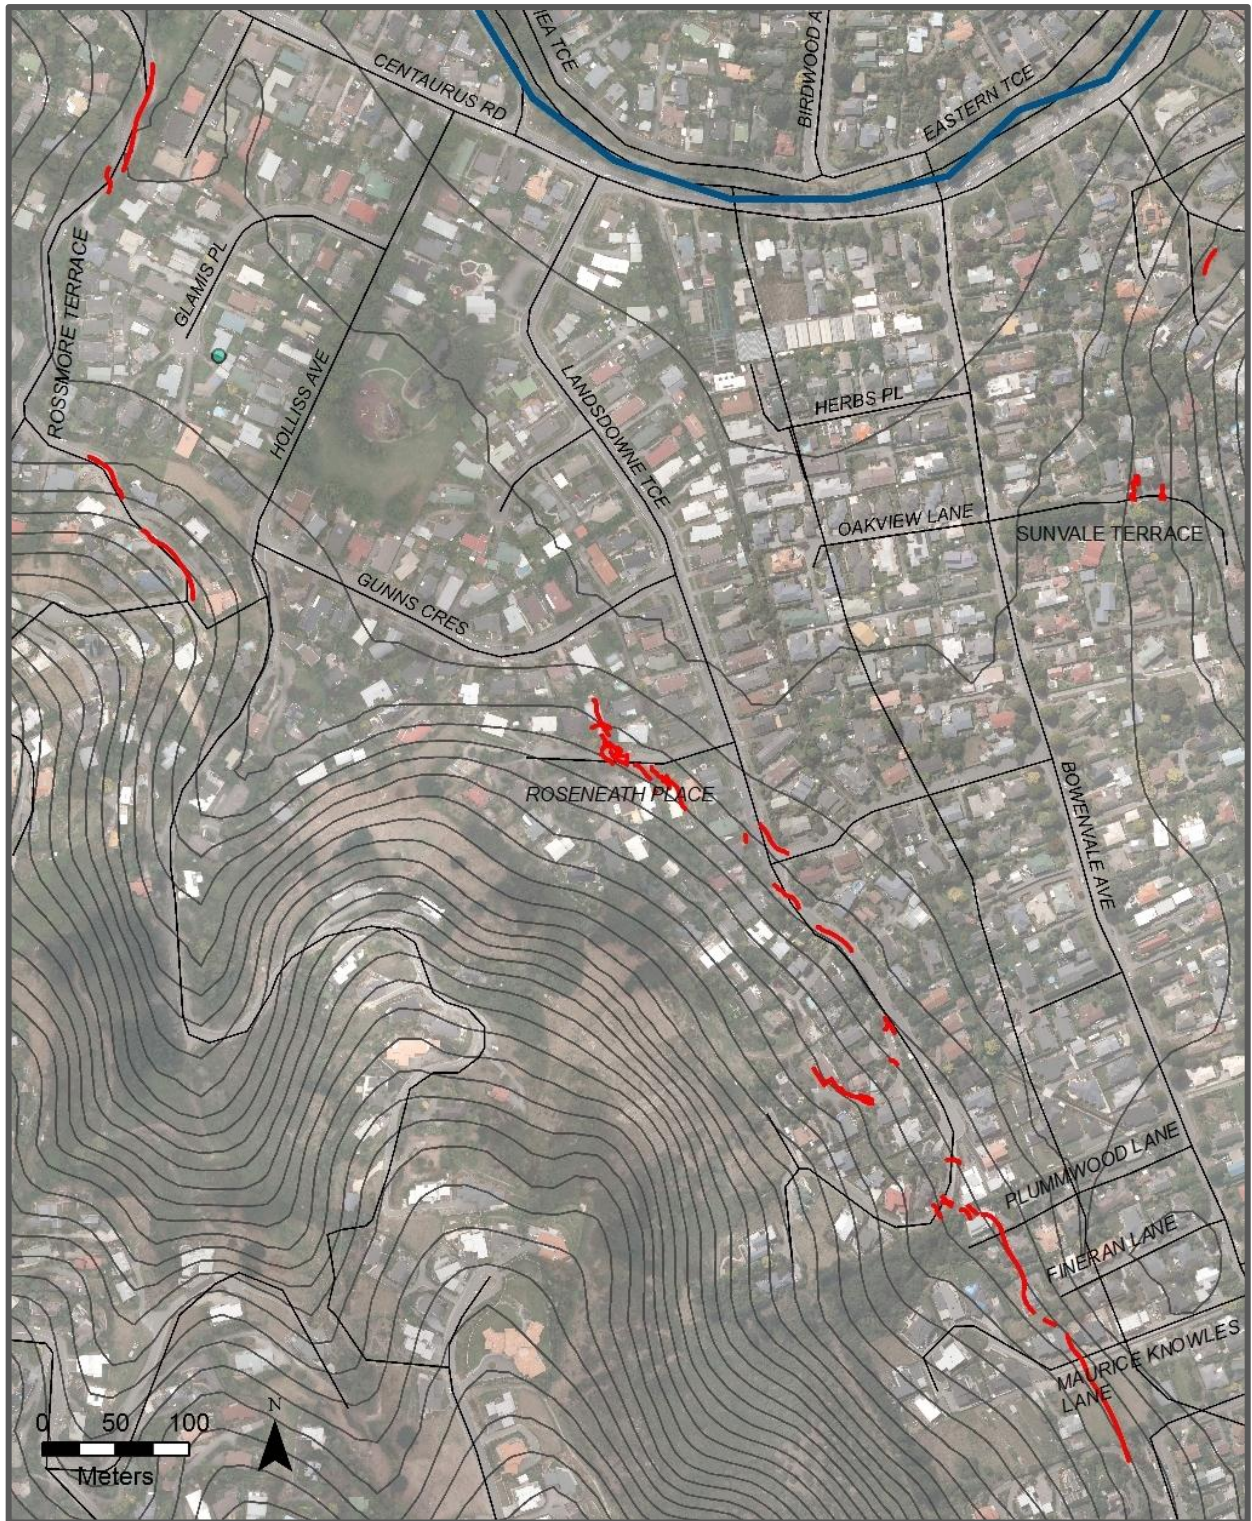
Aside from occasional smaller instances of fissuring near Princess Margaret Hospital, Bowenvale Valley is the westernmost site of major fissuring on the Port Hills (Figure 3.6). The fissuring in the Bowenvale Valley area occurs predominantly on the western side of the valley, extending from a vacant section on Maurice Knowles Lane, through properties to Landsdowne Terrace, and ending in Roseneath Place. Two 20-30 m sections of fissuring also occurred in the upper end of Rossmore Terrace, a short distance west of Roseneath Place, as well as a 50-60 m section near the bottom of Rossmore Terrace. A short section of fissuring was noted to cross Sunvale Terrace on the eastern side of Bowenvale Valley, outside 7 Sunvale Terrace; however this did not appear to extend further than roughly 20 m. The trace is discontinuous and roughly contour-parallel, as is typical for the Port Hills fissures, in this case being predominantly between the 25 m and 30 m (above sea level) contours. A detailed cross section of the Bowenvale Valley fissure trace is provided in Figure 3.7.

In the Bowenvale Valley, in particular near Plumwood Lane (Figure 3.6), the fissure trace orientation appears dependent on factors which cause it to follow a path of least resistance, or least tensile strength. The fissure trace divides and re-forms several times in the area. Fissures pass directly through 8 Plumwood Lane. Since the fissure appears to have divided into several smaller traces at this point, most of which circumvent the house, the impact on the house at 8 was lessened, although the lower storey and garage did separate slightly from the upper half. A larger fissure was observed at 5 Plumwood Lane, of approximately 100 mm wide, passing beneath the centre of the house. This was evident as several cracks in the patio area which combined to form a single large split through the house. There is extensive evidence of land and fill movement in this area with the retaining wall to the north of the house having moved eastwards towards the centre of the valley, causing cracking to form in the fill behind. The crack continues into 9 Fineran Lane where it passes beneath the house, effectively splitting the house in two down the peak of the roof.

Figure 3.6 Bowenvale Valley fissure traces.

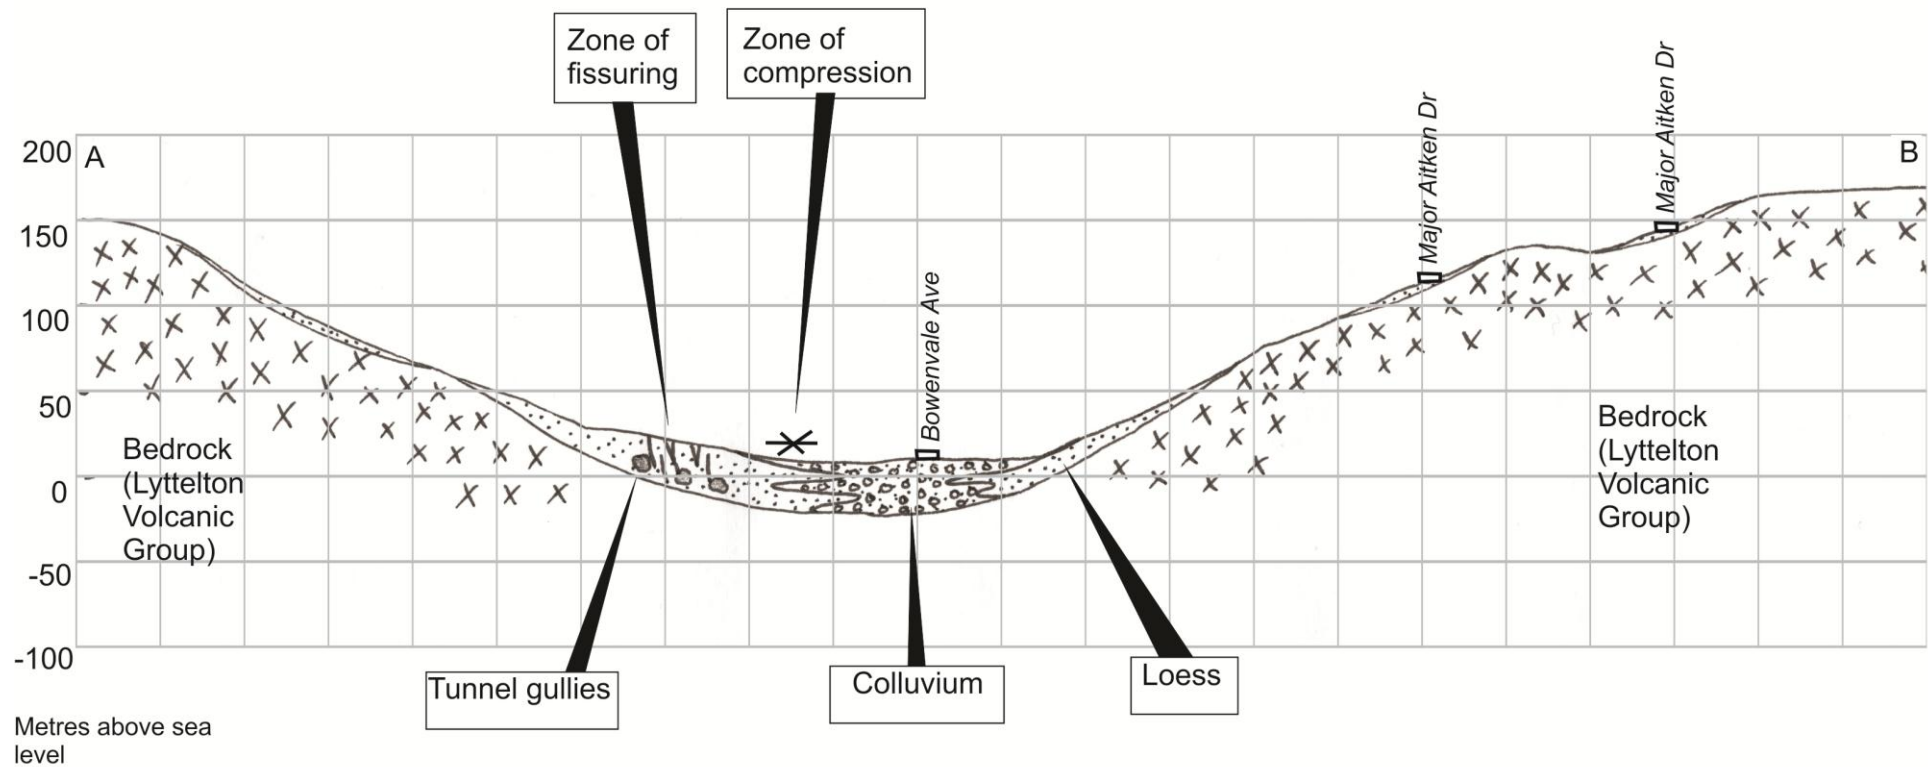
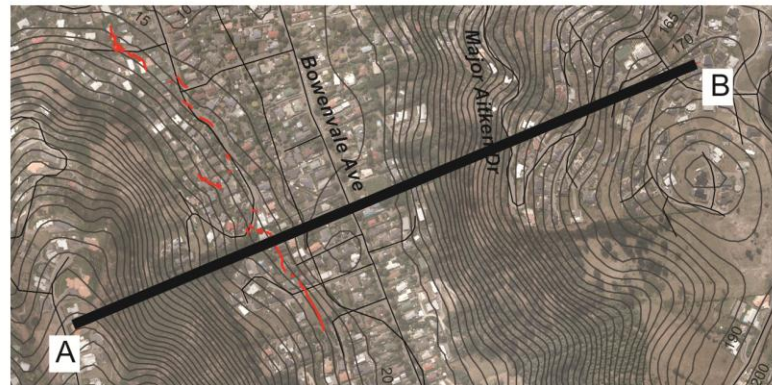
Figure 3.7 Schematic cross-section through Bowenvale Valley, at natural scale however size of fissures exaggerated approximately 10x, in order for clarity of observation. In reality they would extend only slightly into the loess layer. Bedrock and valley fill loess-colluvium mapped based on geological map in Brown and Weeber (1992).

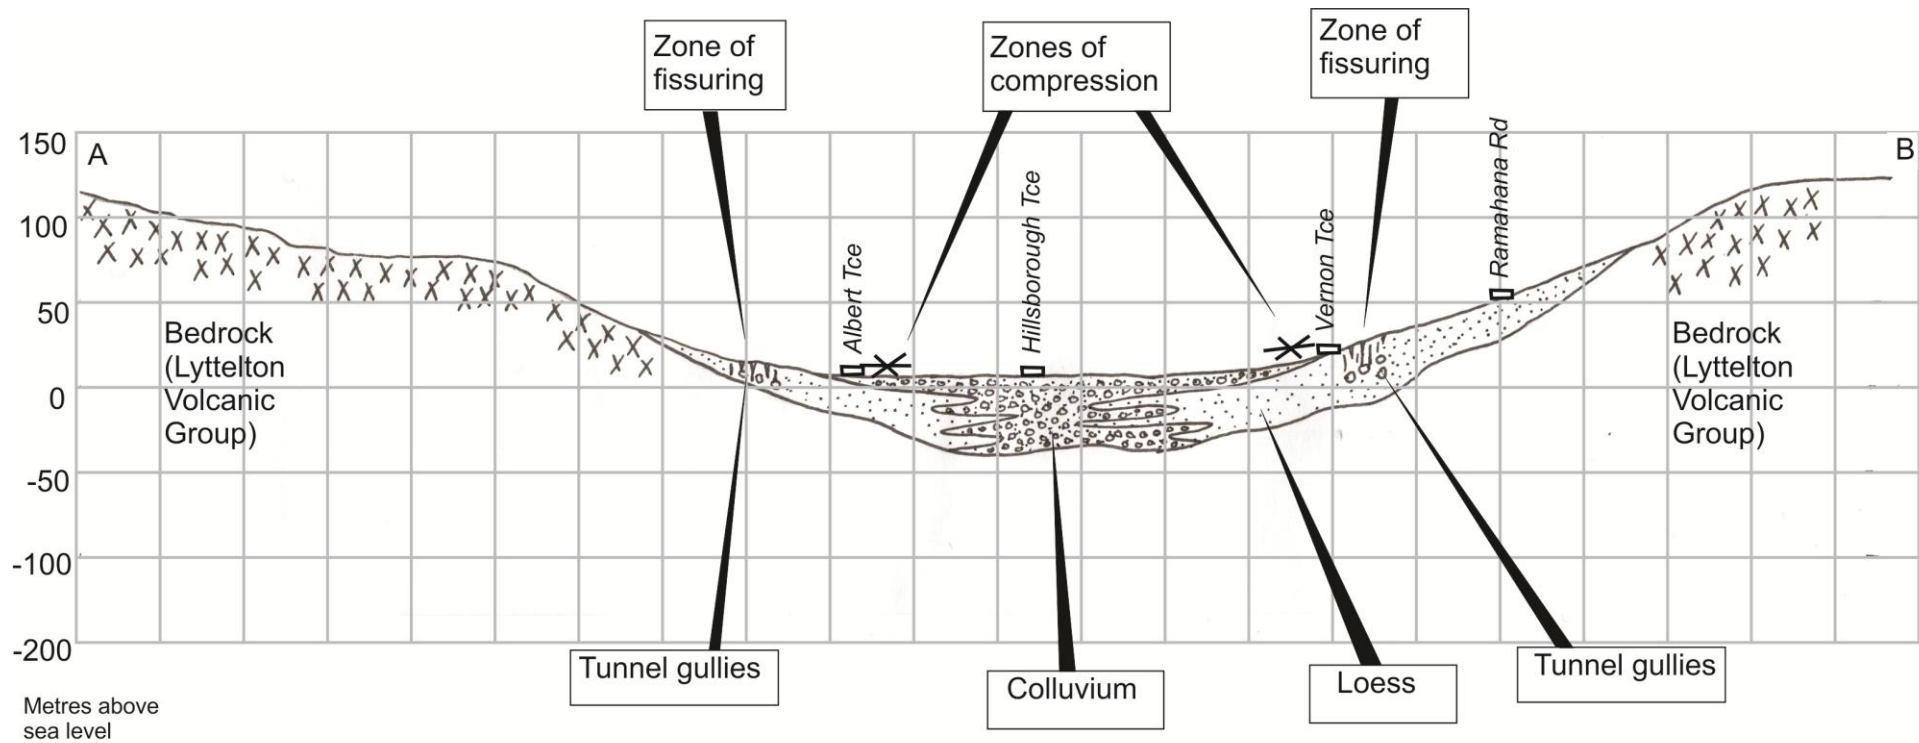
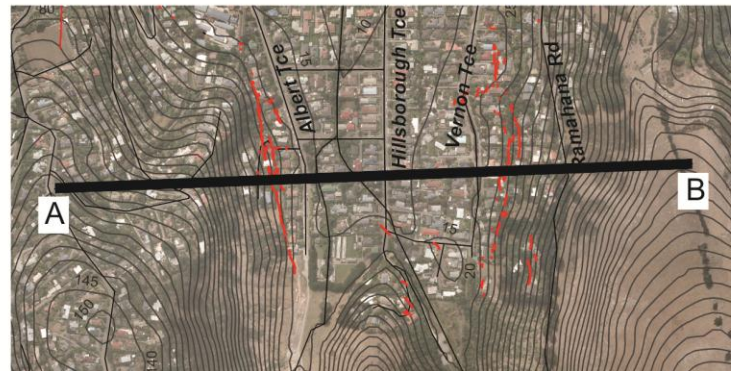
The Vernon Terrace fissures were observed to continue to creep for some time following the Christchurch Earthquake, and it has been postulated that the fissures formed on a pre-historic landslide head-scarp (Dellow et al. 2011a). A detailed cross section of the Hillsborough Valley fissures is provided in Figure 3.9.

Figure 3.9 Schematic cross-section through Hillsborough Valley. Scale: natural scale, however size of fissures exaggerated approximately 5x, in order for clarity of observation. In reality they would extend only slightly into the loess layer. Bedrock and valley fill loess-colluvium mapped based on geological map in Brown and Weeber, 1992.

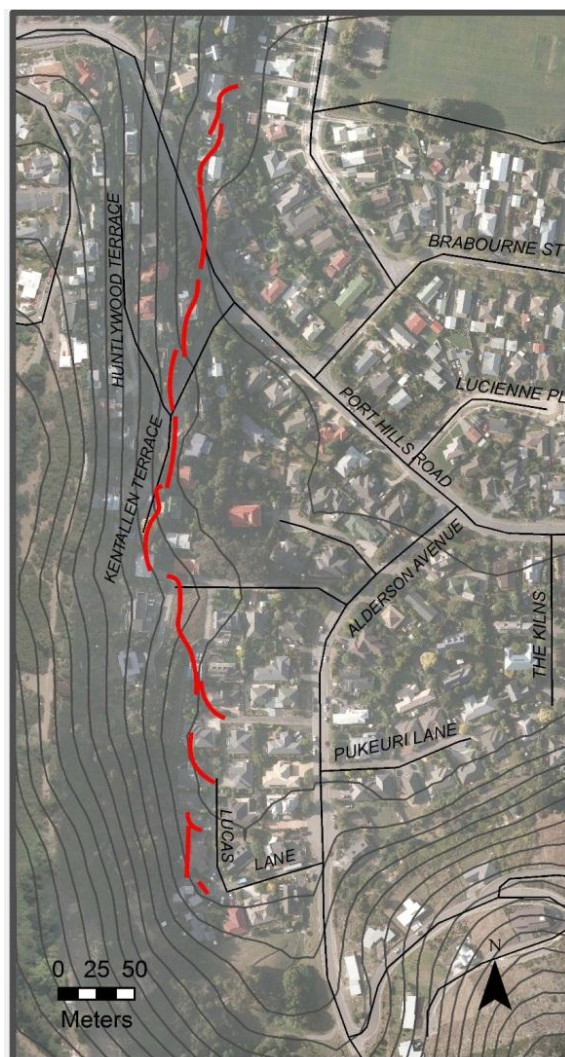
The fissure traces trending from Huntlywood Terrace to Lucas Lane are mapped in Figure 3.10. At the time of writing, a landslide hazard has been declared for Lucas Lane, following heavy rainfall in the winter of 2012. Christchurch newspaper, The Press of 18 August 2012, reported that residents of six houses in Lucas Lane were forced to evacuate on the 14th of August. The paper also reported that review of aerial photographs of the area had indicated the presence of an historic slip on the slope above Lucas Lane. An historic brick quarry was located in the Lucas Lane area, which may have been a contributing factor to the landslide risk in the area.

Figure 3.10 Fissure trace from Huntlywood Terrace to Lucas Lane. Mapped following pers. comm. R. Hunter.

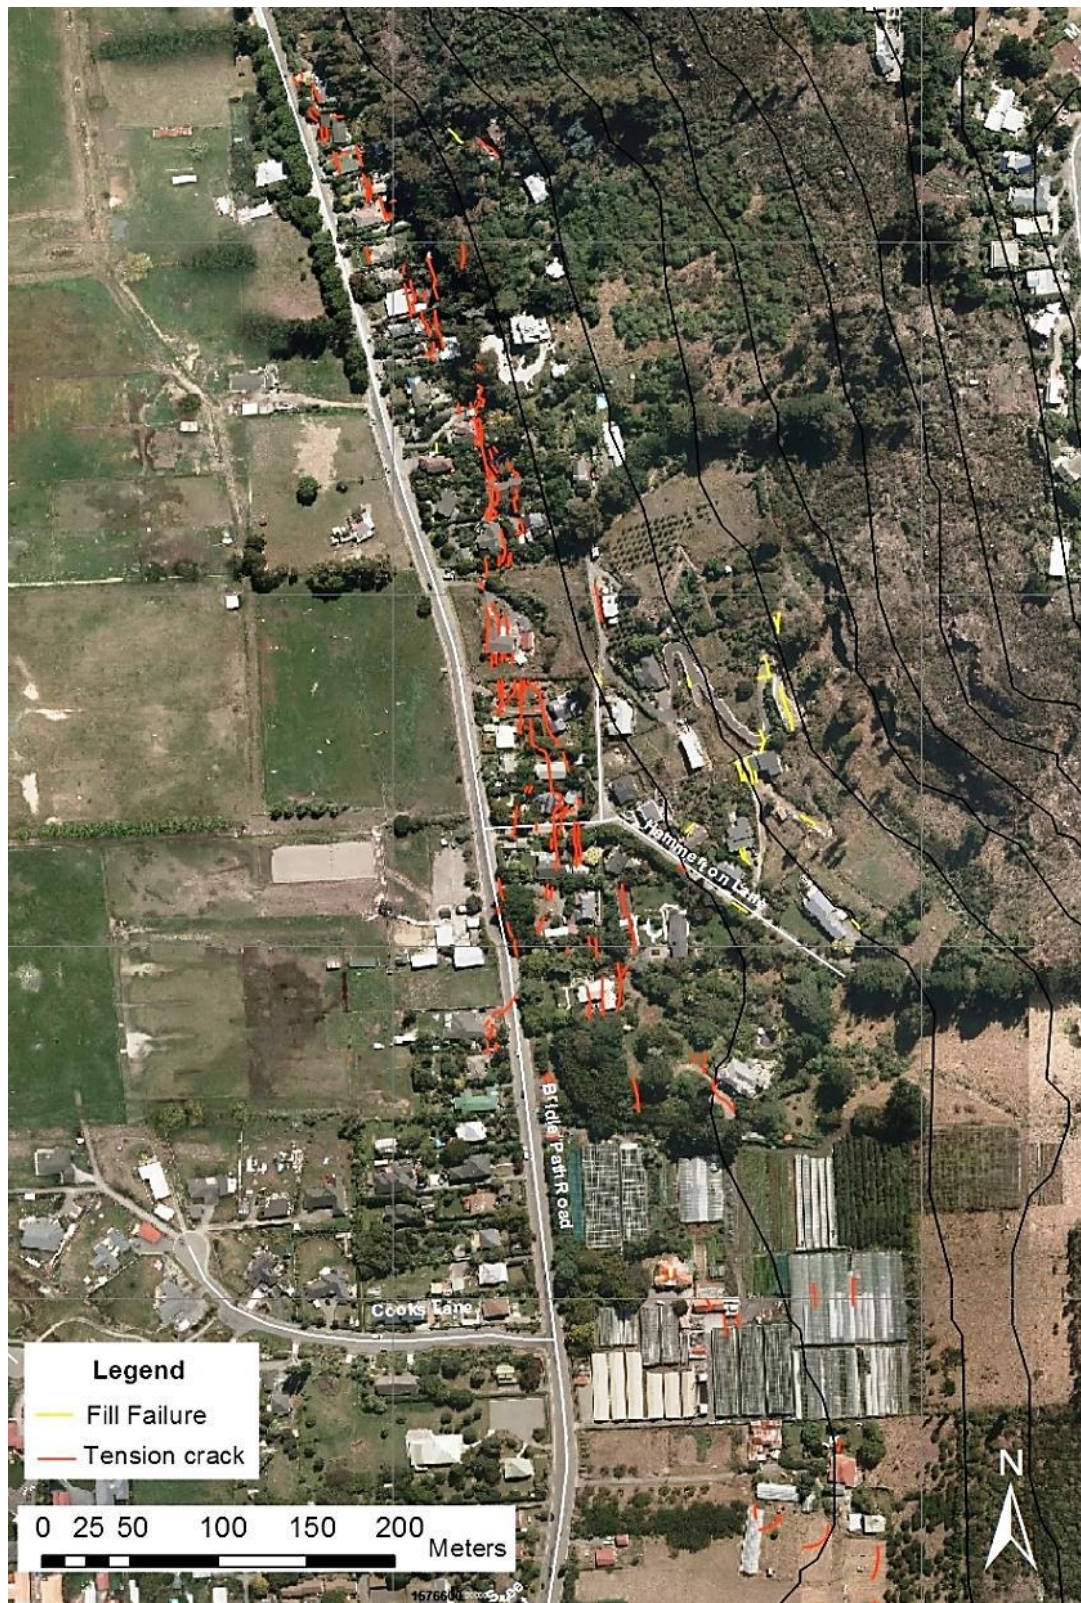
The Bridle Path Road fissure traces extend for some 400 m, in a semi-continuous manner (Figure 3.11). The Christchurch Earthquake's epicentre was directly below the Heathcote Valley, and the high vertical ground acceleration of 2.2g was recorded nearby. Extensive fissuring formed along driveways leading uphill from Bridle Path Road (Figure 3.12), as well as many failures of areas of fill, and liquefaction occurred in the valley floor. Movement monitoring devices set up following the Christchurch Earthquake indicated that the Bridle Path Road fissures continued to creep for some time afterwards (Dellow et al. 2011a). The fissure traces were discontinuous, with lengths of up to approximately 20 m. These sections of fissures overlapped and extended the 400 m distance of Bridle Path Road in effect forming a linear fissure "zone", passing through the houses and drives to the east of Bridle Path Road. Driveways perpendicular to the fissure zone showed the movement most readily, with paved areas being separated by fissures of up to 200 mm in width, such as those seen in Figure 3.12. In Hammerton Lane, being at a slightly higher elevation to the fissures along Bridle Path Road properties, fissuring was also observed, however it was attributed to being the result of localised fill failure (Figure 3.11).

Figure 3.11 Bridle Path Road fissure traces. Map adapted from Engel and MacFarlane, unpublished memo, 2011.

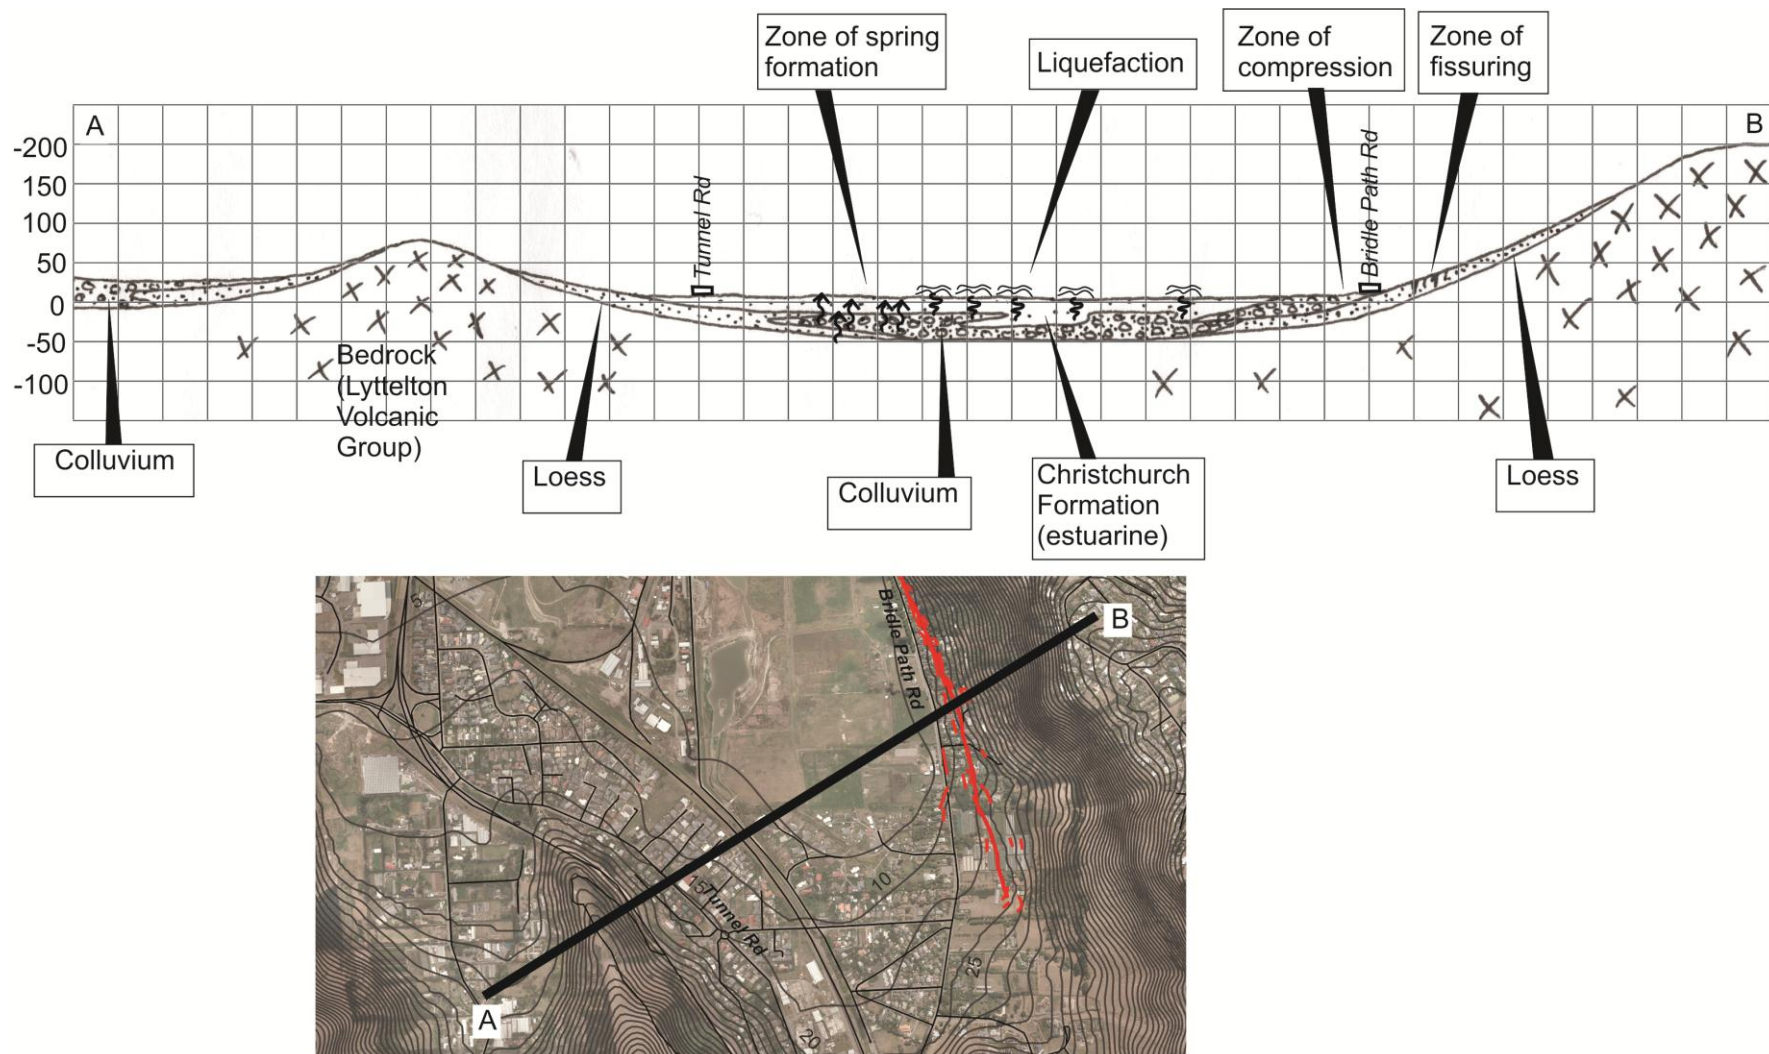
A schematic cross section of the Bridle Path Road fissures is provided in Figure 3.13, showing the relationship of the fissuring to the location of the bedrock outcrops higher up the hillslope, and to the valley floor sediments below. Springs are shown reaching the surface towards the west of the valley, and liquefaction is indicated where it was observed in the central valley sediments.

Figure 3.13 Schematic cross section through Bridle Path Road valley, with bedrock and Christchurch Formation mapped based on geological map in Brown and Weeber, 1992. Springs indicated by upwards wavy arrows, and liquefaction by wavy lines on surface. Scale: natural scale, however size of fissures exaggerated in order for clarity of observation. In reality they would extend only slightly into the loess layer.

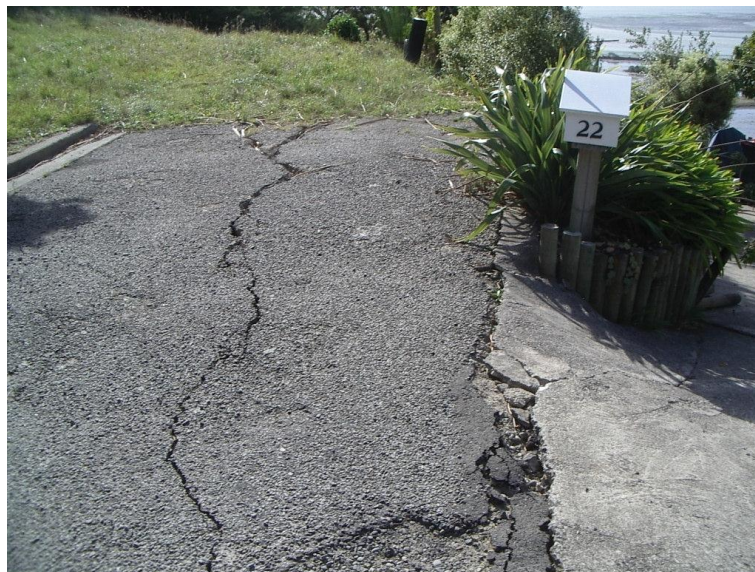
The fissuring at La Costa Lane (Figure 3.14 and Figure 3.15) was first noted during ground inspections during March 2011. The fissuring had severely damaged the land at 16 La Costa Lane, and the owners indicated that their house had moved east from the road-side by the fissuring. At 14 La Costa Lane, fissuring had similarly caused a wooden car port structure to detach from the road and collapse. The Maffey's Road fissures are aligned with the crest of the hill, thus trending approximately perpendicular to the contours. These may or may not be related to the La Costa Lane fissures, which do follow the more common contour-parallel alignment. The La Costa Lane fissures differ from those further to the west in that they are at a higher elevation, being up to 65 m above sea level, and being almost directly on the loess-bedrock interface. Some minor fissuring was also noted along Basil Place, in the valley below La Costa Lane. Again this is unusual, as in other locations, fissuring has been accompanied by lower level compression, rather than further fissuring. The Basil Place fissuring is on slopes of lower gradient, and only approximately 15 metres above sea level.

Figure 3.14 Cracking outside 22 La Costa Lane. Engel and MacFarlane, unpublished memo, 2011.

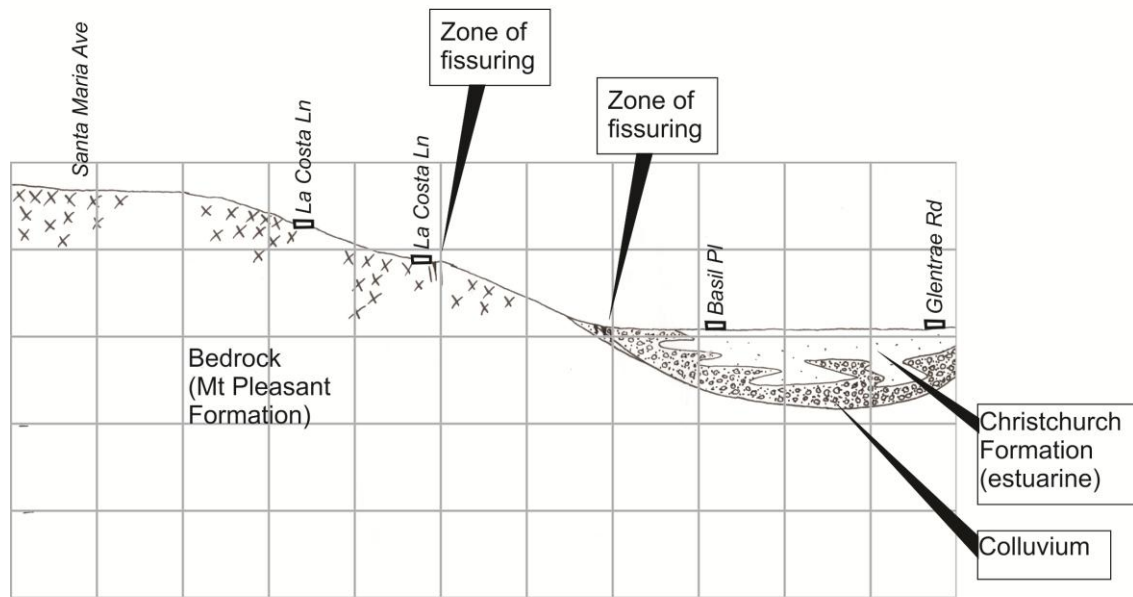
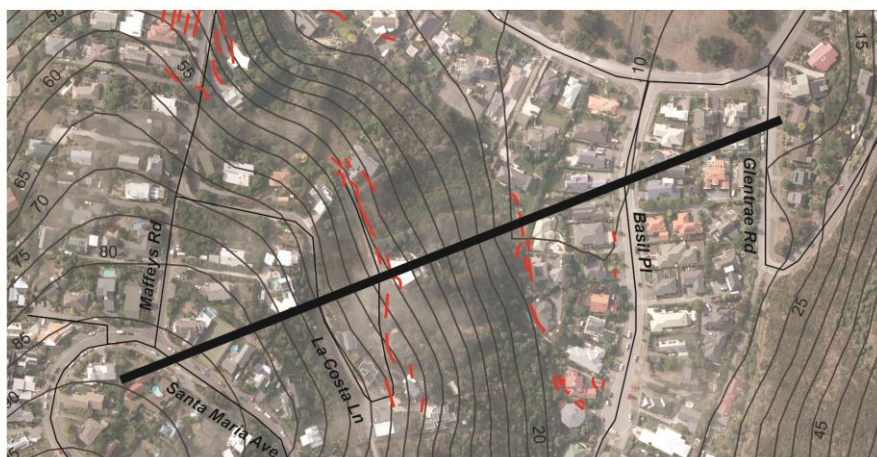
Figure 3.16 Schematic cross section through La Costa Lane fissures. Bedrock and Christchurch Formation mapped based on geological map in Brown and Weeber, 1992. Scale: natural scale.

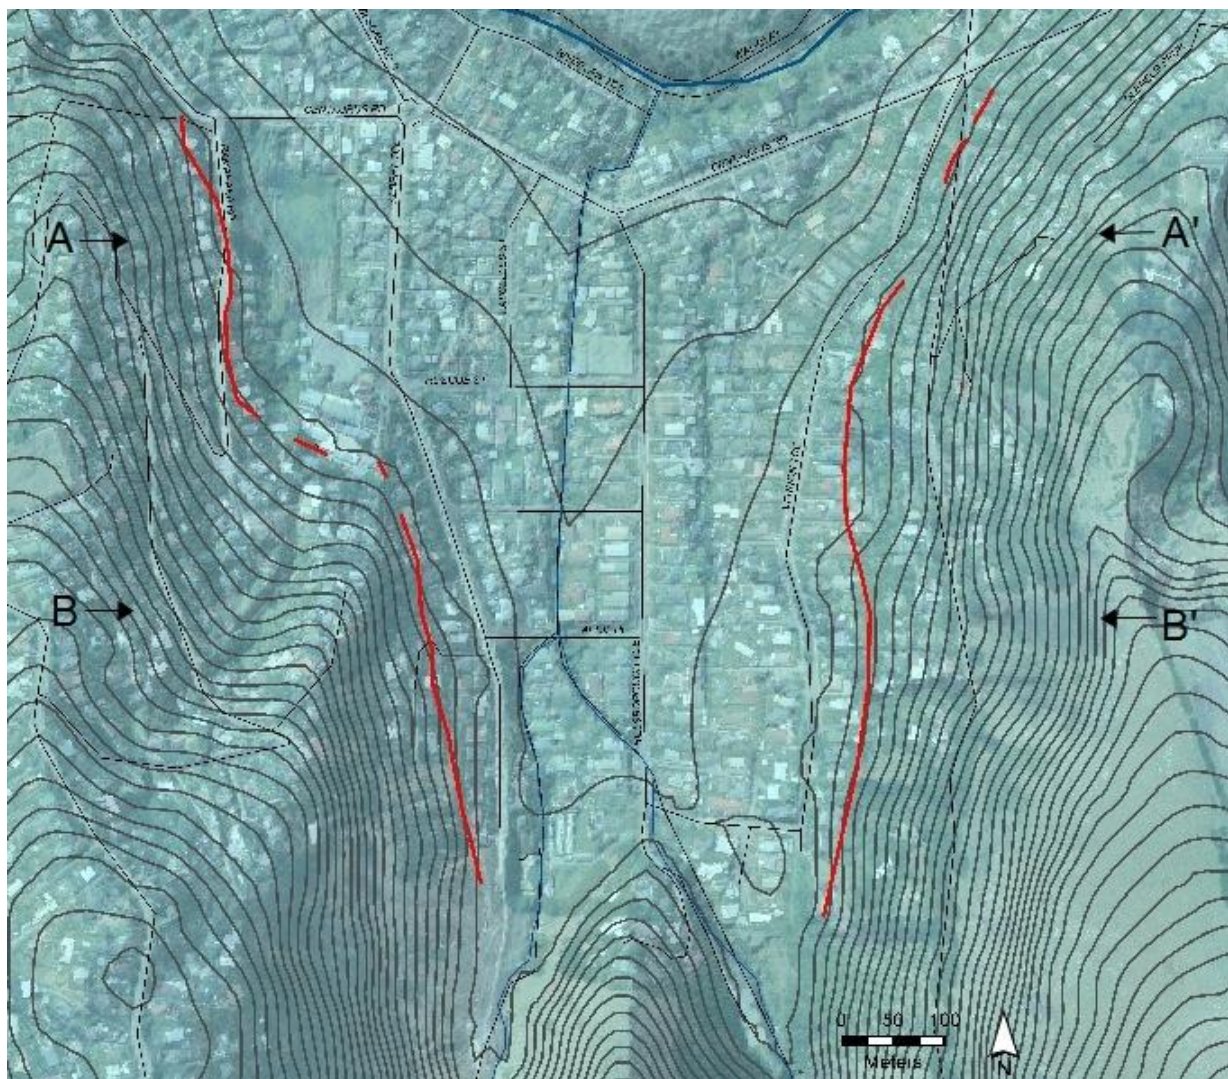
The fissuring on either side of the Hillsborough Valley has been mapped through properties from Albert Terrace to Ramahana Road on the western side, and between Vernon Terrace and Rapaki Road on the eastern side. The fissure traces run in a roughly contour-parallel orientation, each extending for a distance of 500-600m, as shown in Figure 4.1.

Figure 4.1 Simplified fissure traces on either side of the Hillsborough Valley, shown in red. Topography shown by 15 m D.E.M. from LiDAR data, and 5 m interpolated contours. A-A' and B-B' indicate profile locations, as seen in Figure 4.4.
